CONFIDENTIAL INSPECTION REPORT

17 Clyde Rd
Flemington NJ 08822

April 2, 2021

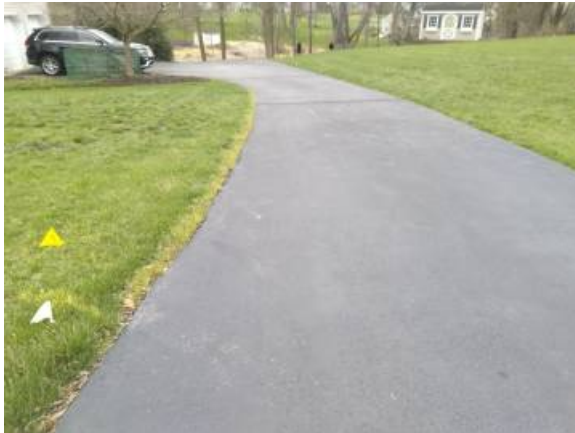
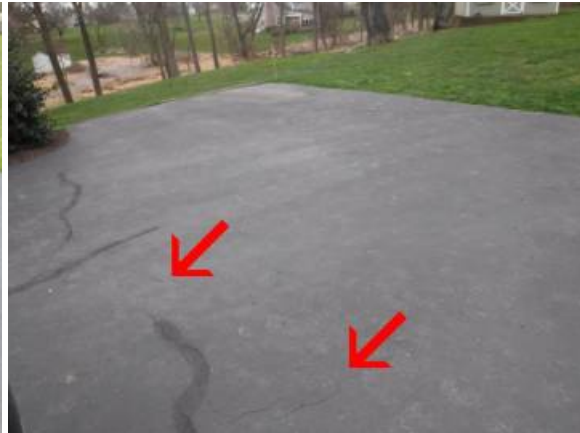
Common cracks (1/4-inch or less) were visible in the driveway at the time of the inspection. Cracks exceeding 1/4 inch should be filled with an appropriate sealant by a qualified professional to avoid continued damage to the driveway surface from freezing moisture.

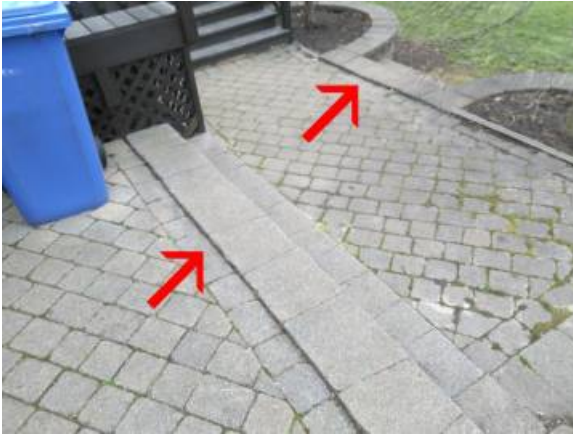
2.3 Condition:

Type: Paver/Tile. It was noted the surface has areas that are raised & settled. Tripping hazards were also noted. This is where an abrupt change of 1" or more in the height of the surface is seen. Recommend to have repaired by a qualified professional.

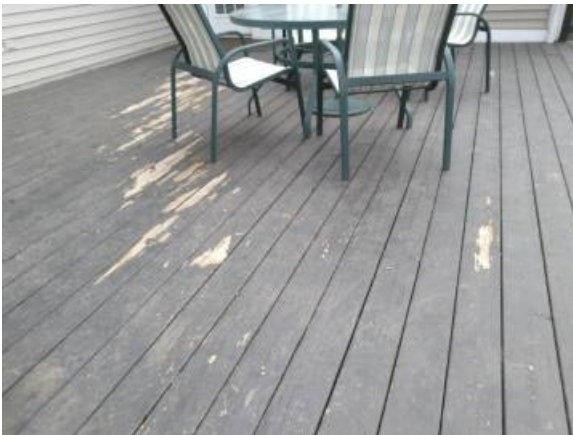
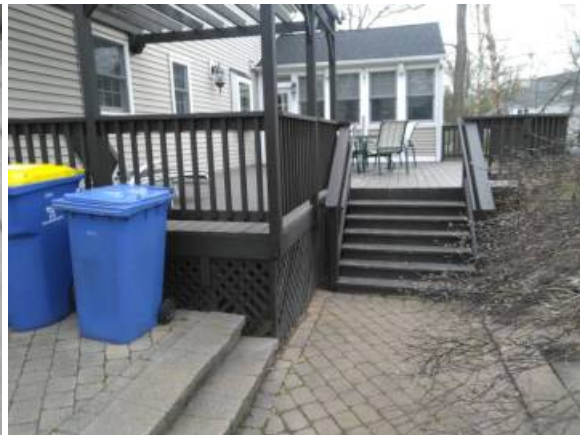
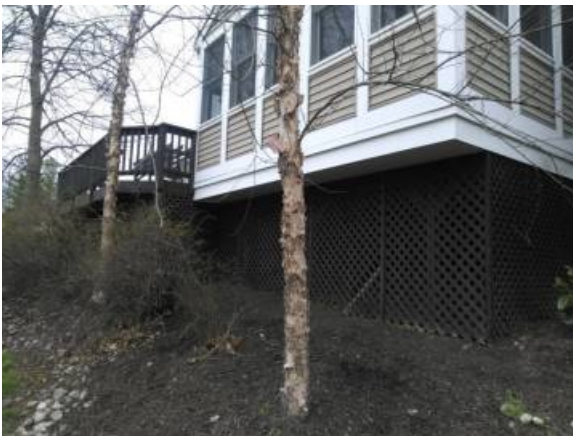
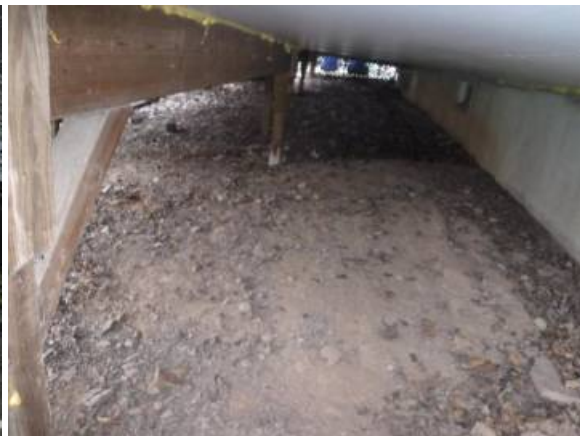
2.4 Condition:

Deck surface is in need of maintenance to prevent continued deterioration. The deck should have routine maintenance performed on a regular schedule by a qualified professional. This will increase the decks life expectancy. Access hatch was sealed, inspector was able to observe underside through lattice hatch gaps. The Inspector specifically disclaims defective conditions in all areas not visible from access hatch.

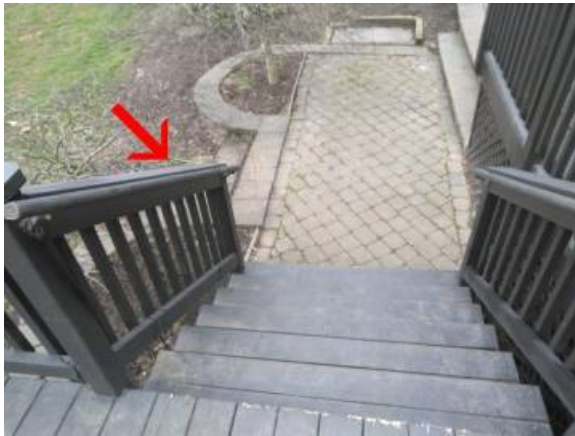
2.5 Stairs Condition:

- Handrail are loose. This condition is a potential fall hazard. This should be corrected by a qualified professional.

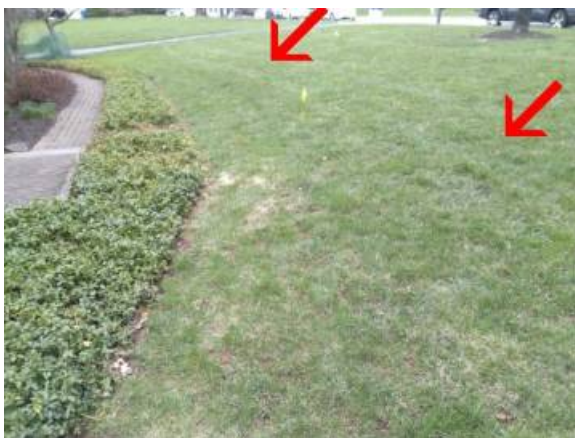
- Flat to negative grade was observed near the house/foundation in a few areas. Always pitch the slope of soils away from the foundation. Slope should fall away from the foundation at a minimum of 1/4" inch per foot and extend at least 6 feet away from the foundation. This is a common deferred maintenance concern that can be found in the majority of homes. Failure to have the correct grade can result in a wet basement along with unusual settlement in a building.

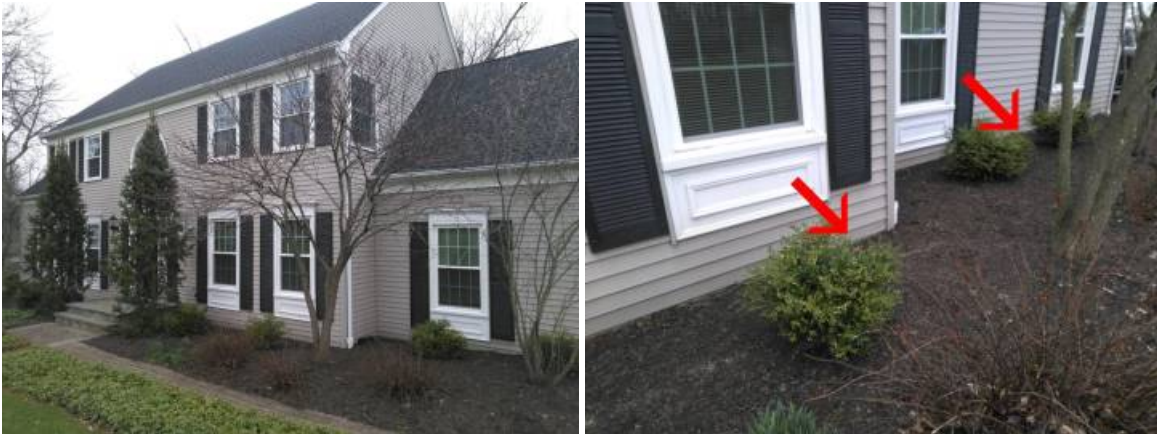
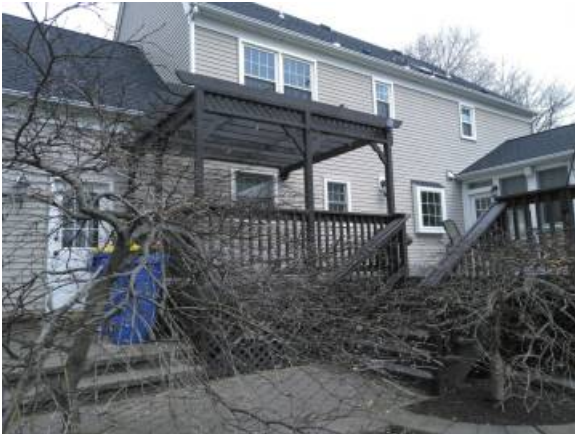
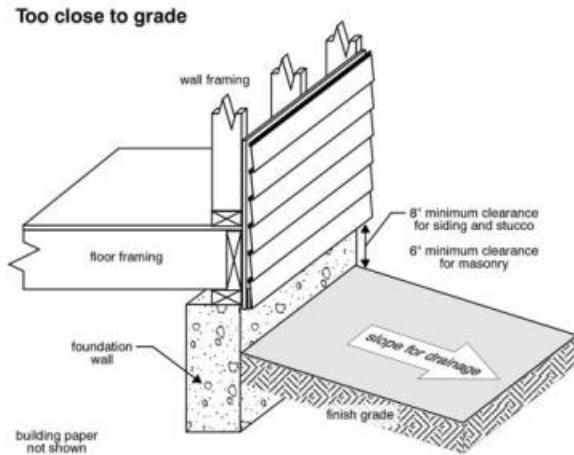
3.1 Materials & Condition:

Cladding is to close to grade. All types of exterior cladding should not be any closer than 6" to 8" above finished grade to prevent damaging water wicking and insect entry to the wall envelopes. If a foundation doesn't exist in this area it should be installed. Recommend to expose the masonry foundation between exterior finished grade and the existing wall cladding. Recommend to have corrected by a qualified professional.

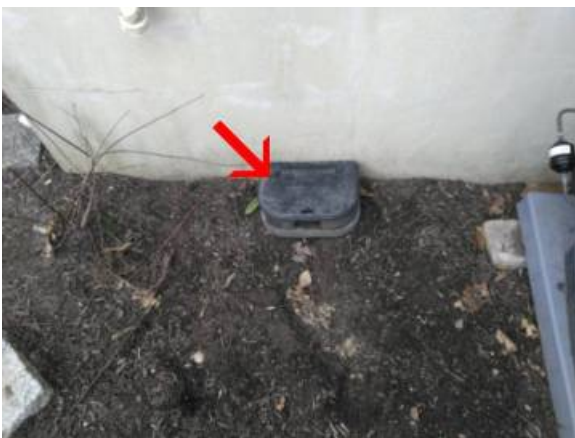
3.2 Other Observations:

- The exterior of the home had rodent traps which indicates prior/current rodent activity. The Inspector recommends that you contact a pest control contractor to confirm rodent problem has been resolved prior to the end of your inspection obligation deadline.

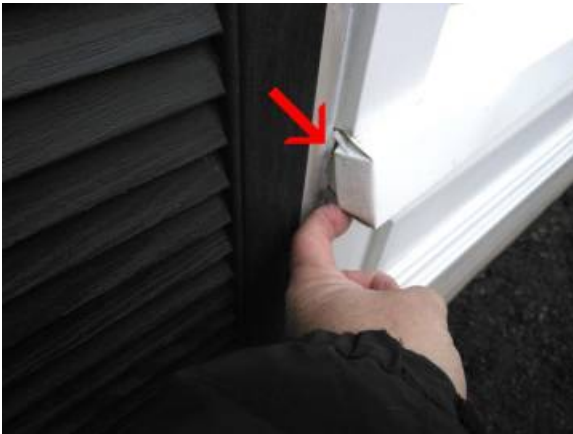
3.5 Condition Of Sills:

At the time of the inspection one or more window sills were flashing was not secure. This exposes the wood to the elements and can cause water infiltration and deterioration. Recommend to have corrected by a qualified professional.

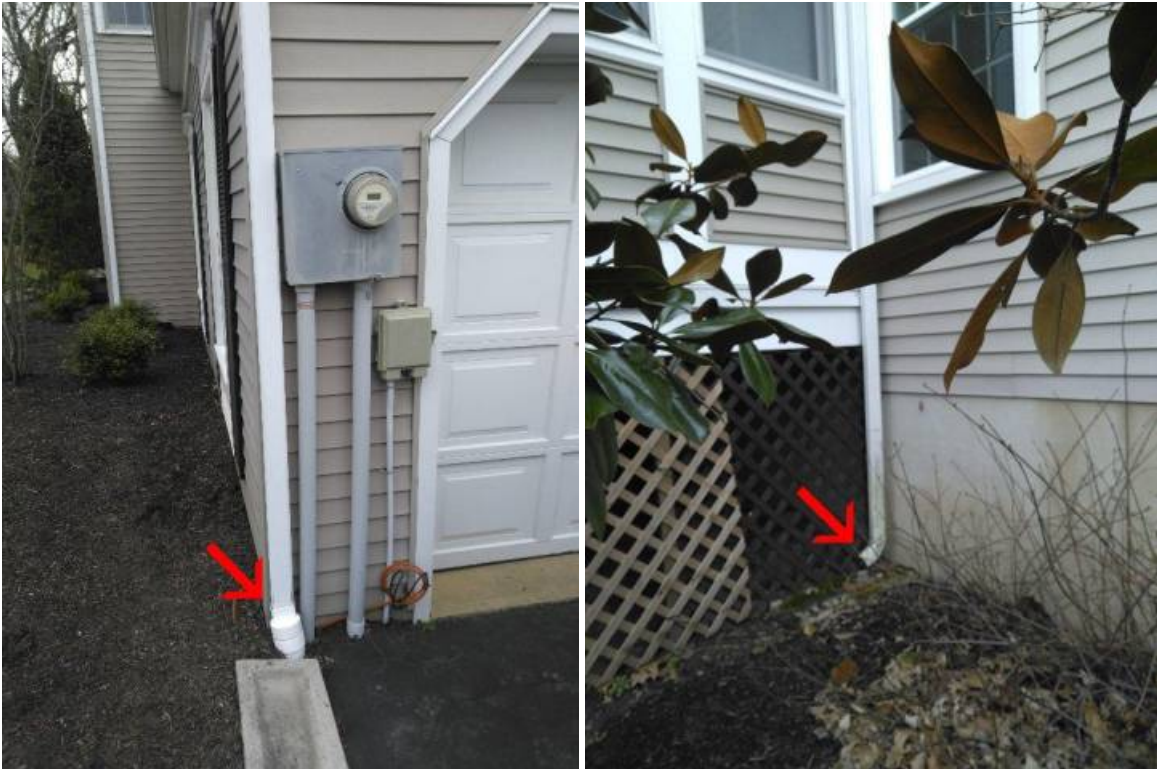
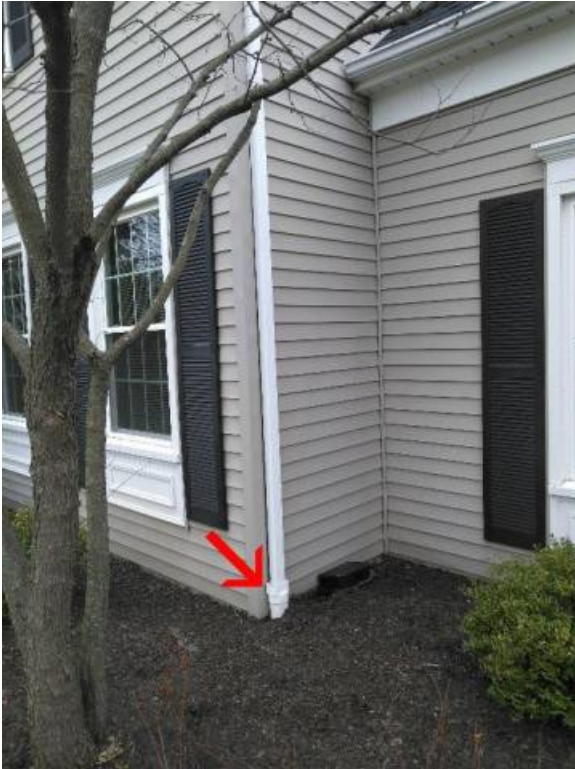
3.6 Type & Condition:

One or more downspout(s) discharge next to foundation. Excessive moisture levels in soil near the

foundation from roof drainage can result in structural failure due to foundation movement or moisture intrusion with the potential to cause structural damage from decay. Moisture intrusion can also cause the development of unhealthy conditions in indoor air related to microbial growth such as mold fungi. Recommend to Extend downspout to route rainwater at least 4 to 6 feet away from the structure by a qualified professional.

One or more downspout(s) drain into underground piping. The destination of the water after its entry into the ground is unknown. Recommend discussing drainage and piping with the owner. An evaluation of the underground pipes can not be made since the interior of the pipe is not visible.

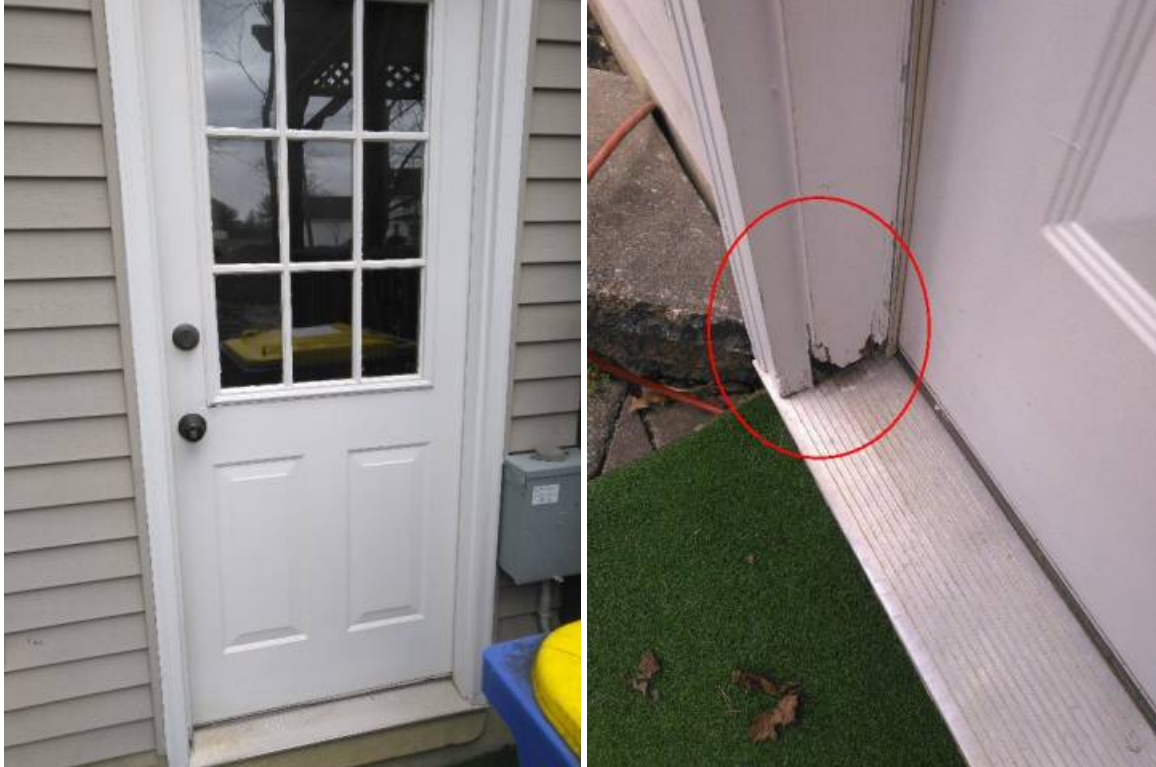
DOOR FRAME: Minor rot is noted at the lower portion of the doorframe. Recommend to have repaired by a qualified professional.

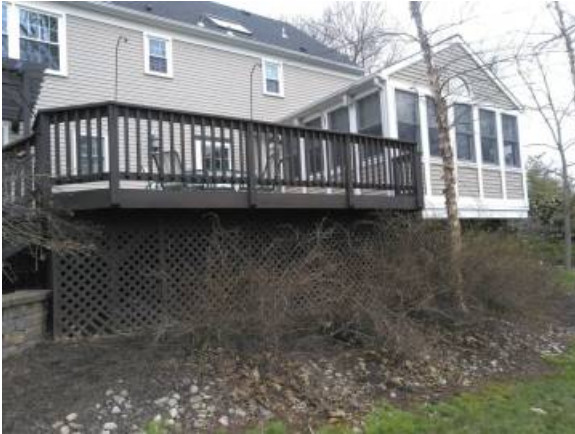
3.9 Materials & Condition:

A parge coat was visible at the foundation exterior surface. Parge coats are layers of Cementitious, plaster-like material applied with a trowel and designed to harden, cover and protect the exterior surface of the foundation wall. Therefore visibility and ability to inspect the foundation exterior wall material was not possible and is disclaimed.

visible portions were inspected. Visibility was limited due to Deck.

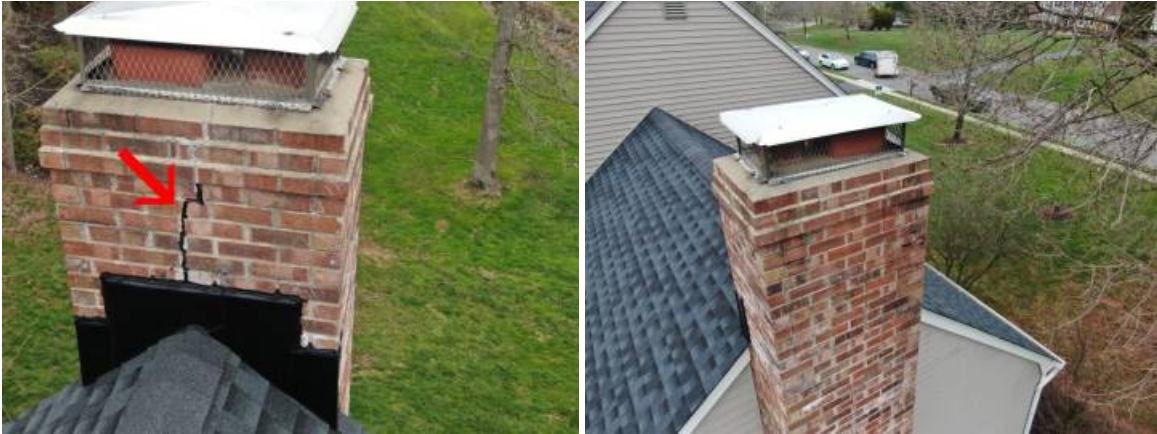
4.1 Chimney Exterior Condition:

Cracks were noted and have been sealed. This will help avoid damage to the chimneys exterior from freezing moisture. You should be diligent in having sealants examined annually and re-applied as needed.

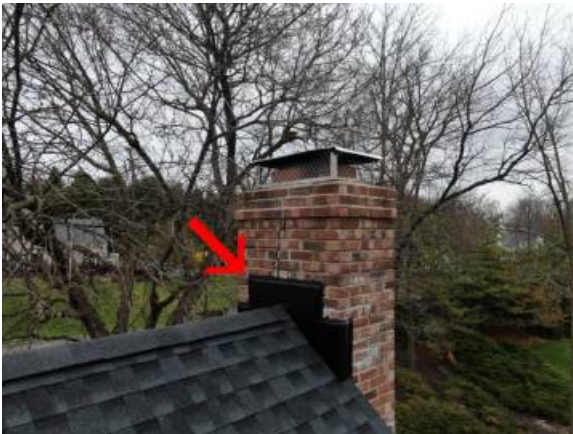
4.2 Flashing:

The area at which the chimney meets the roof was reliant upon a sealant to prevent moisture intrusion of the roof structure. Sealants eventually dry, shrink and crack and can allow moisture intrusion of the roof assembly. Moisture intrusion can result in damage to the home structure or materials from decay or deterioration and may result in conditions which encourage the growth of microbes such as mold. You should be diligent in having sealants examined annually and re-applied as necessary by a qualified professional.

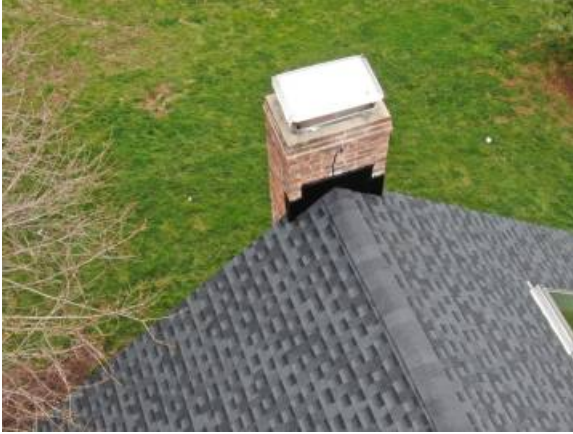
**4.3 Chimney Cap/Crown:**

There is a chimney cap. The chimney caps function is to keep water from entering the stack and causing deterioration. The chimney cap is made of, metal. This cap is functioning as intended.

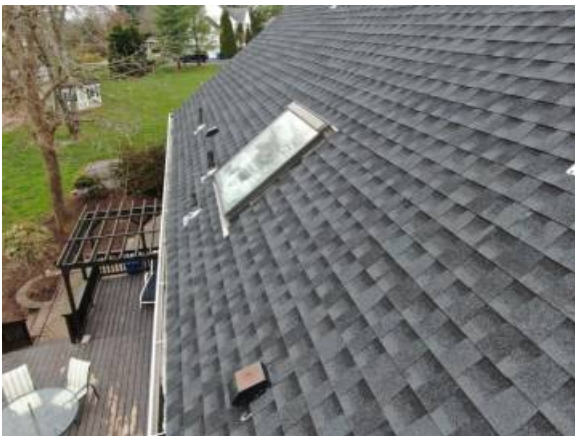
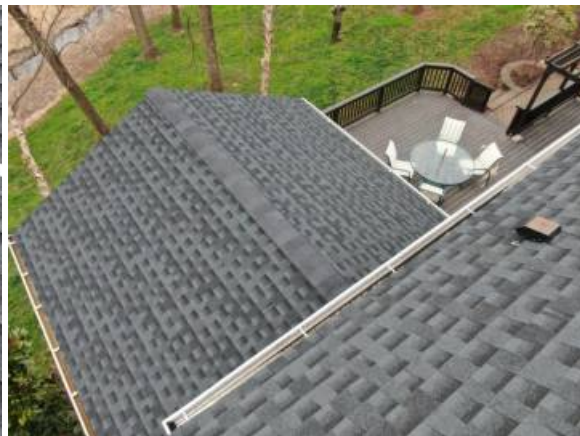
5.4 Roof Condition:

Appears serviceable. General condition appears serviceable with normal signs of weathering/curling and aging. Regular maintenance and inspections are advised.

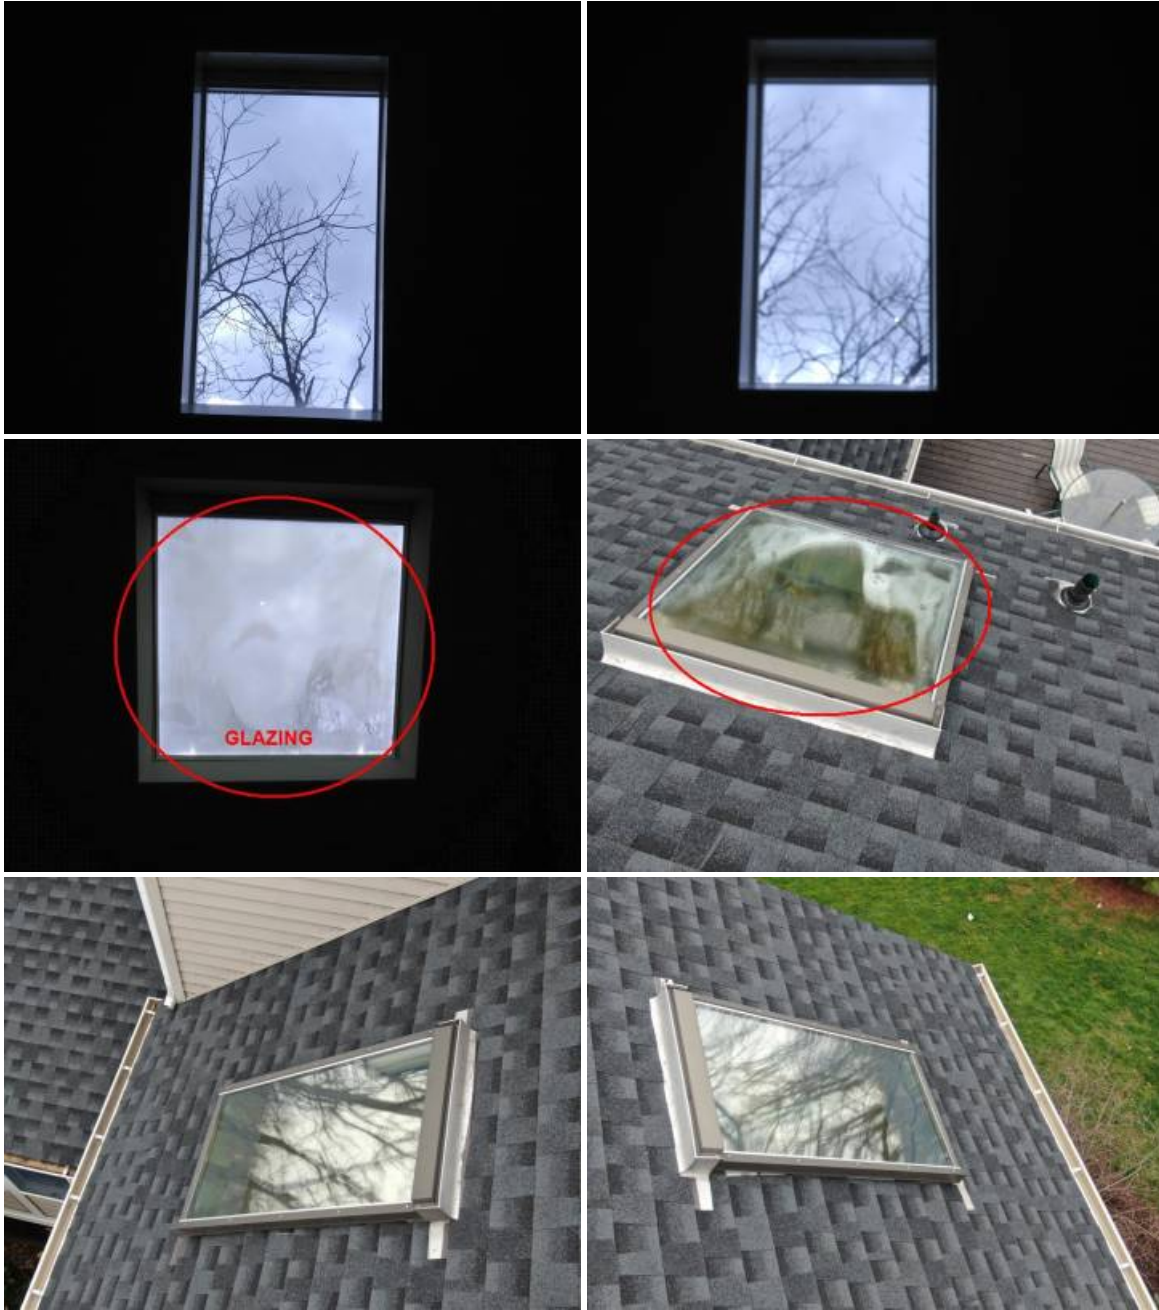
5.5 Condition:

The skylight in the bathroom had double-pane glazing in which stains which appeared to be the result of condensation were visible at the time of the inspection. This condition indicates a loss of thermal integrity. The skylight should be repaired or replaced as necessary by a qualified professional.

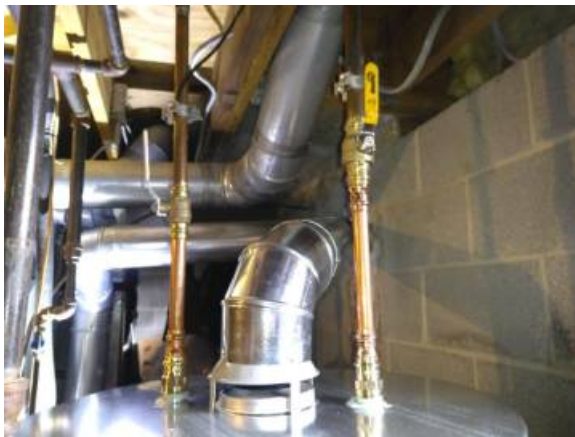
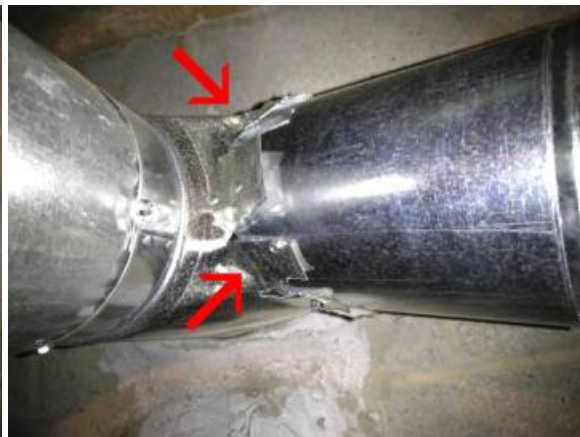
8.6 Condition:

The vent pipe "Y" that was supplied was not approved for this purpose. Gaps were also noted. This condition has the potential to allow the toxic products of combustion to enter the living space. **The Inspector recommends immediate replacement by a qualified HVAC contractor.**

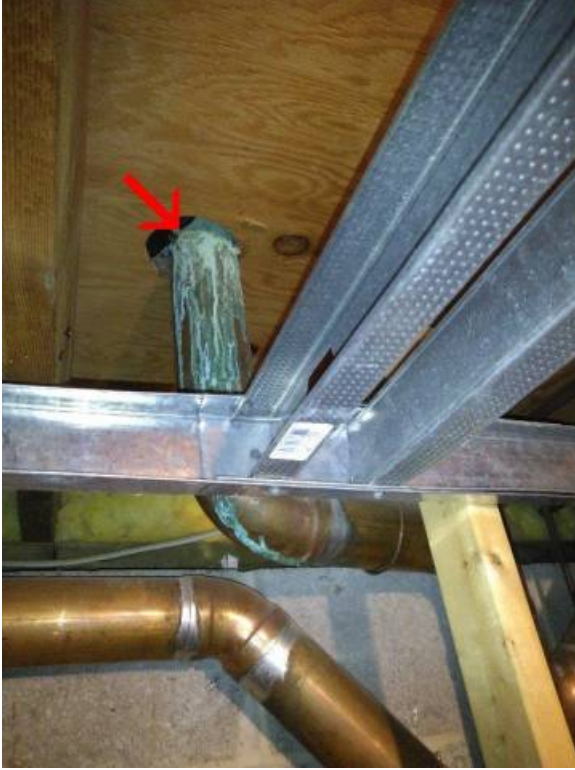
8.12 Condition:

Surface rust/corrosion was noted. It appears to be from a current/prior leak above the floor which was inaccessible to the inspector. The Inspector recommends to ensure leak has been repaired/fixnd corroded piping is replaced by a qualified contractor.

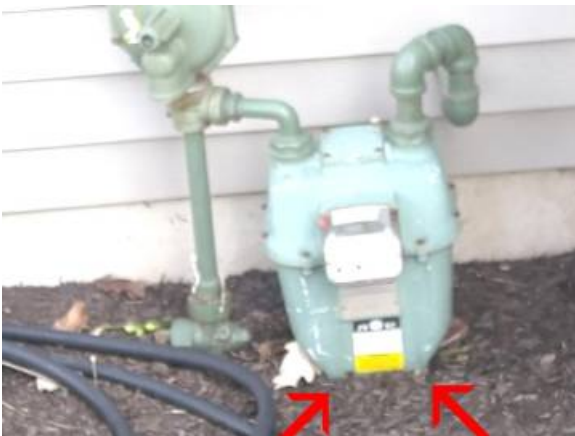
The grade should be 6" below base of meter, this will prevent prematurely aging of the meter. Should lowering the grade create surface runoff that drains towards the foundation a window well should be installed around the meter. This excavation will ensure that runoff is kept away from the meter and foundation. Recommend to have grade lowered to at least 6" below base of meter by a qualified professional.

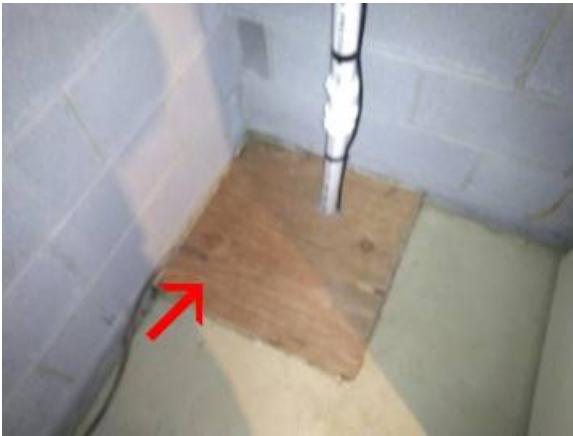
- Cover to sump pump is sealed and could not be removed. This is common with homes that have radon mitigations systems such as this one. Because the sump pump cover could not be remove the sump pump was not inspected.

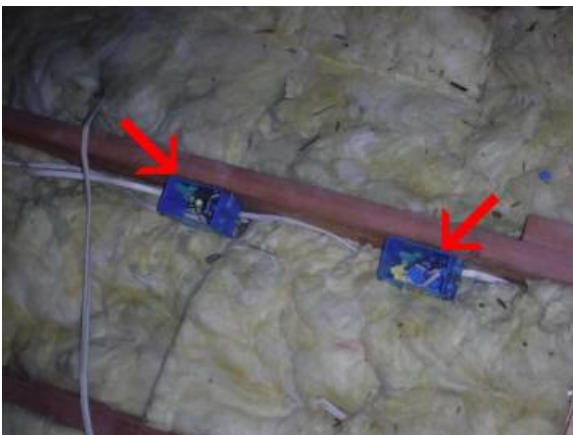
- One or more electrical junction boxes without covers were noted. Electrical junction boxes without covers are a **FIRE HAZARD**. Overheating at any exposed wiring junctions could cause a fire. Electrical junction boxes with covers are used to contain any overheating which may rarely occur. Each of the areas where uncontained electrical junctions occur should have an electrical junction box and cover installed. Recommend to have corrected by a licensed electrician.

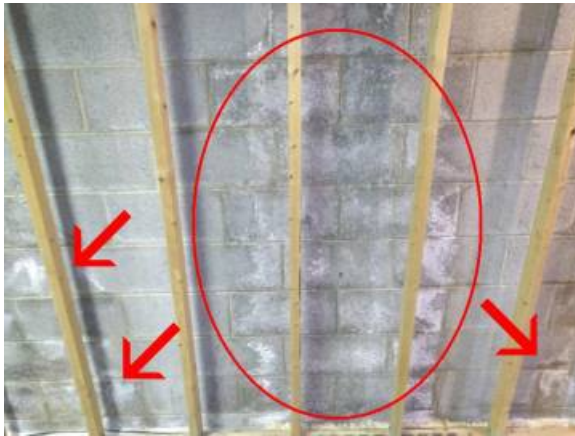
10.3 Moisture:

Efflorescence seen on walls indicates the presence of periodic moisture. Efflorescence (white powdery deposits) seen on walls indicates the presence of periodic moisture. Efflorescence visible on the inside surfaces of the foundation walls in the basement is an indication of moisture intrusion. Moisture intrusion can affect the ability of the soil beneath the foundation to carry the weight of the structure above and may cause structural damage from soil movement. Moisture intrusion can also damage materials and encourage the growth of microbes such as mold. You should monitor this area for future signs of moisture intrusion in an effort to identify and correct the source of moisture.

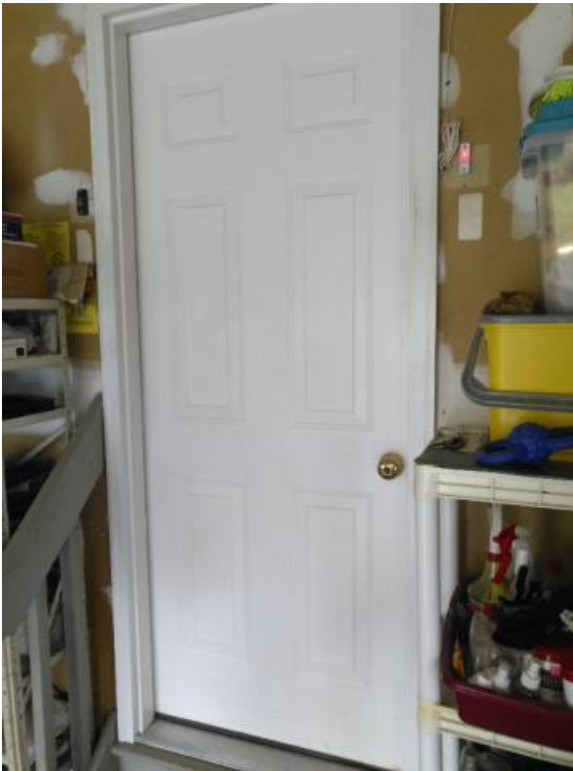
There is a fire rated door separating the garage from the living areas of the house. The door between the living space and the garage failed to close by itself. Modern safety requirements require that the door between the home interior and the garage be self-closing for safety reasons related to fire hazard and toxic fumes. Recommend to have corrected by a qualified professional.
